**CASE
HISTORY
REPORT**

Company name: **DUVIVIER**

Industry: **Motors and Geared Motors Repair Shop**

INPRO/SEAL BEARING ISOLATOR

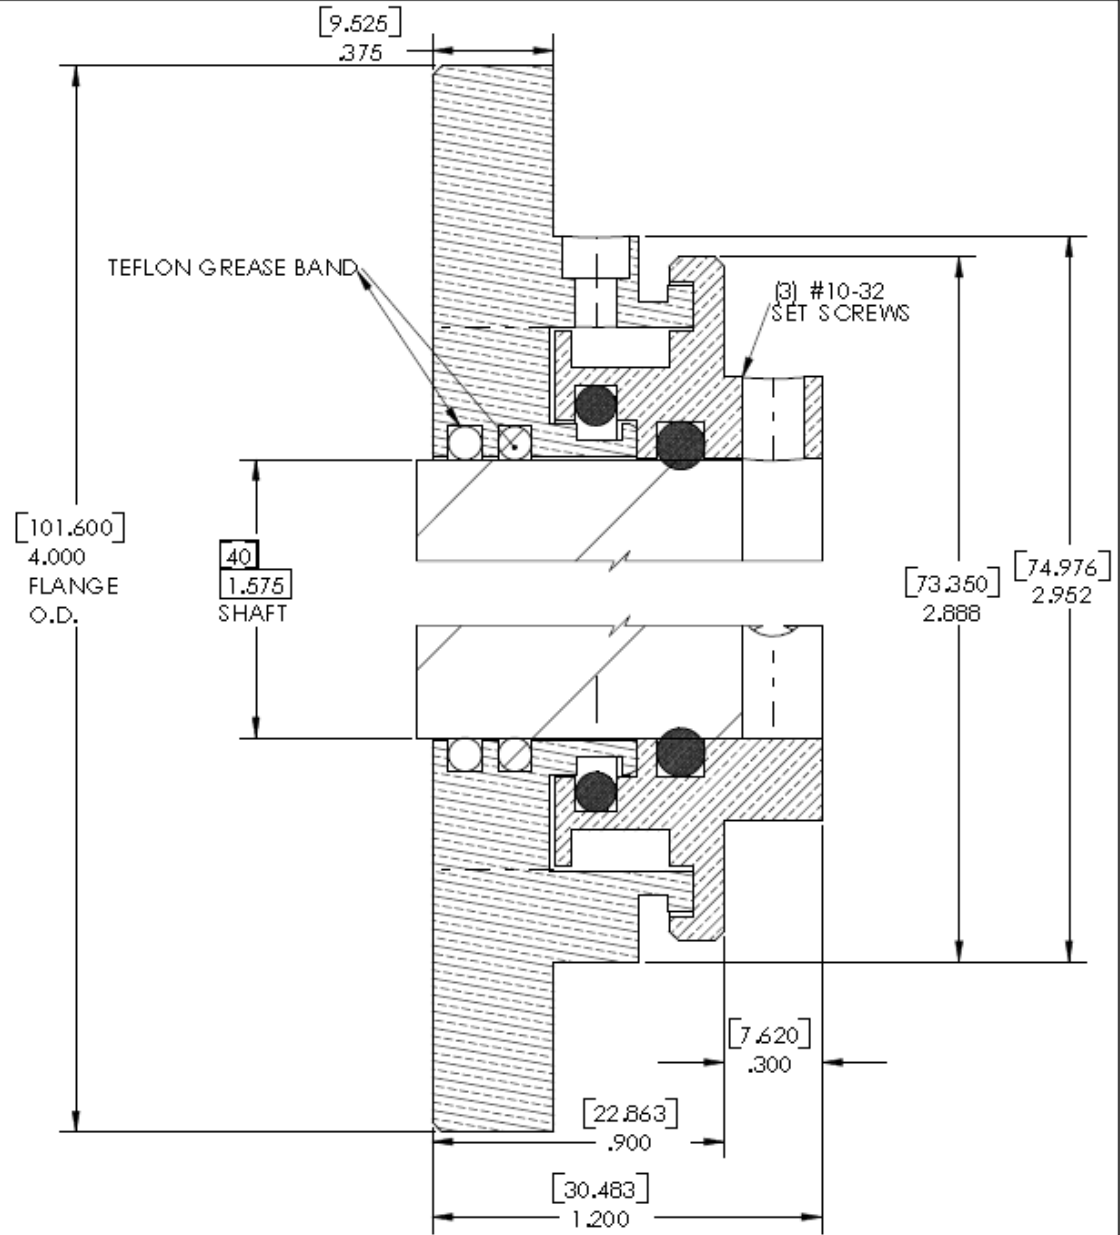
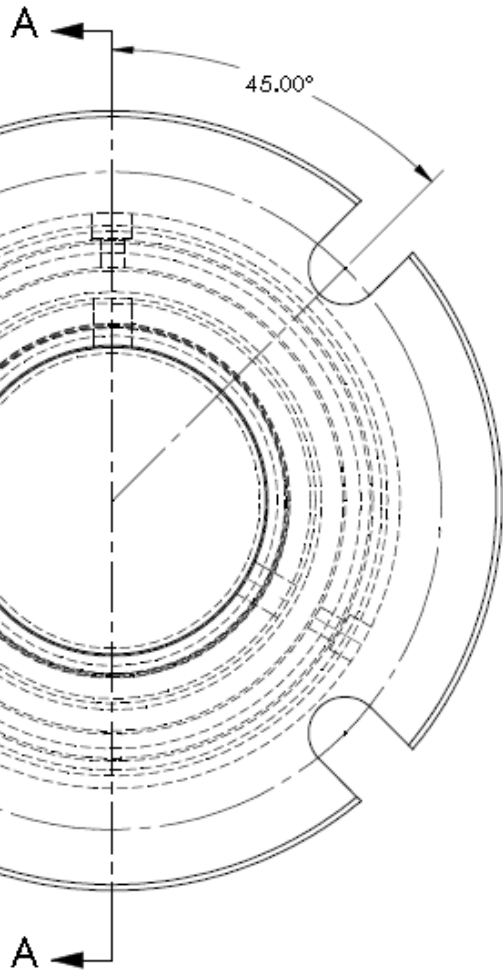
TN13161

The Inpro Seal labyrinth was damaged, we observed:

- 1 - The Stator has turned in the Bearing cover.
- 2 - The Rotor is separate from the Stator.
- 3 - The Rotor has moved and turned on the shaft.

The Regional Manager proposed a special DESIGN to avoid any of these troubleshooting.

1 - Flange Mounting. 2 - Cap Lock Design 3 – Integral Locking Collar.

After 3 months of continuous running the end user has asked Duvivier to install the same Inpro Bearing Isolator on the other mixers.
