Company : LANXESS Industry: Petrochemical Location: La Wantzenau - France Application : Pillow Block

Lanxess elastomer at La Wantzenau (Strasbourg – 67) produces synthetic elastomer.

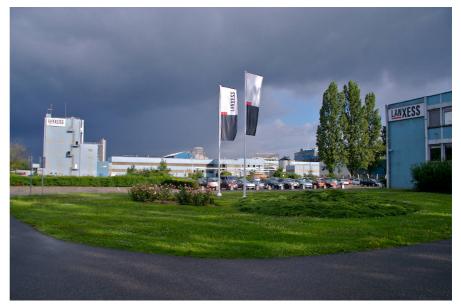
They reguraly have pillow block failure on archimede screw conveyor. The leakage from stuffing box is a mixture of elastomer and water + soda. The screw have to be stopped and repaired every 3 - 4 months.

In 2008 MD Distribution proposed the installation of 4 INPRO/SEAL Sphere Align on two equipments.

To date no failure and no stop of the equipment have been observed.

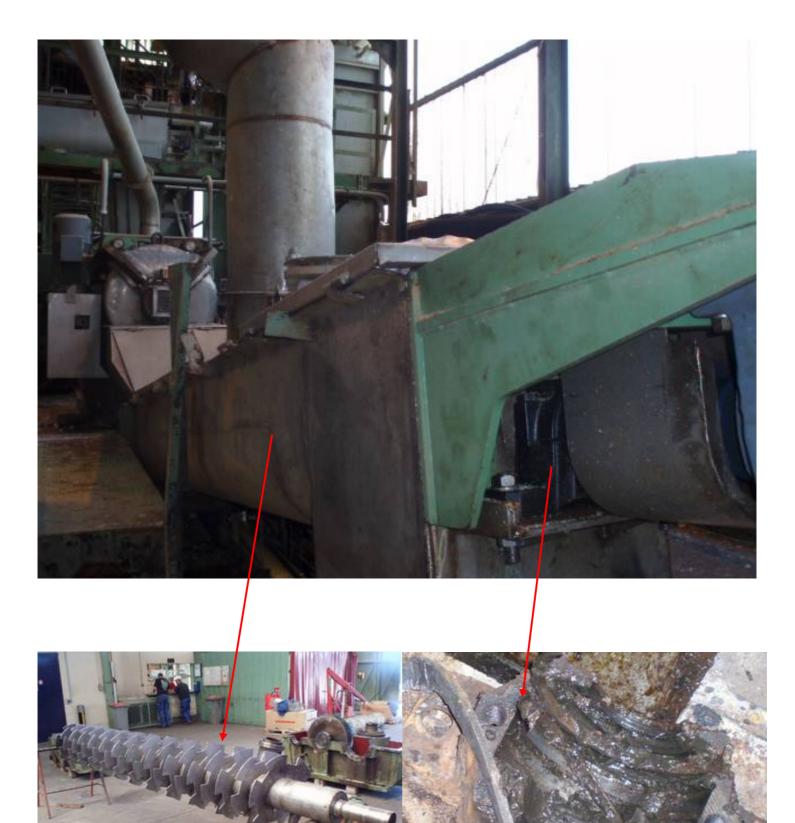
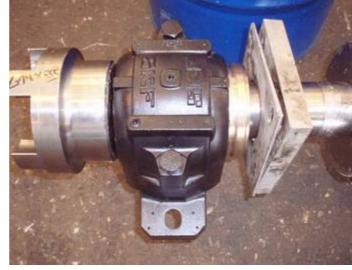
Split Pillow Block SKF - SNH 520-617

Inpro/Seal : VBXX-CAP LOC SPHERE ALIGN Ø 90 mm P/N°: 1401-A-42269-0
