CASE STUDIES: AIR MIZER® | SIDE ENTRY AGITATORS

Six Leaking Agitators Find a Permanent Sealing Solution

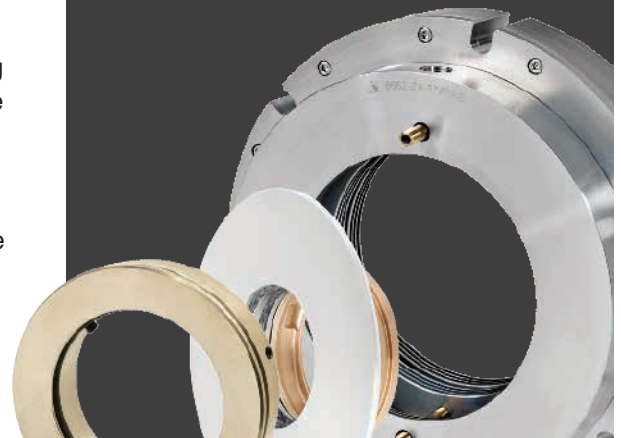
One of two split stainless steel Air Mizers installed on white liquor tank agitators.

In December 2005, a split custom engineered stainless steel Air Mizer was installed on one of the white liquor tank agitators. It proved to be the perfect solution for their leaking agitators. Other installations followed in rapid succession – the second white liquor tank agitator in Aug 2006, and the indoor slurry agitators in 2006, 2007 and 2008.

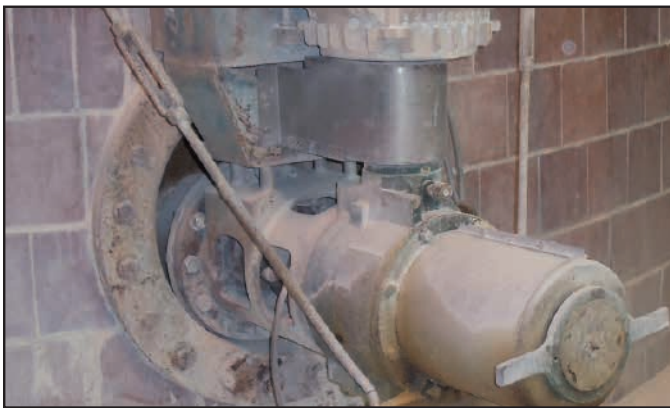
One of four slurry tank agitators installed with Inpro/Seal Air Mizers to eliminate product loss and decrease maintenance costs.
