CASE HISTORY REPORT

INPRO/SEAL

CUSTOMER : **CORUS STEEL**

INDUSTRY : **STEEL MILL**

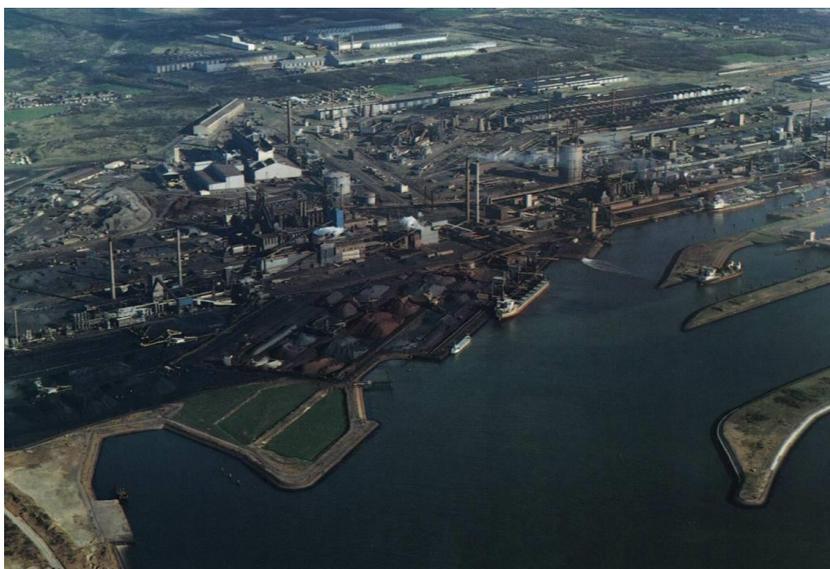
The Steel mill of CORUS STEEL in Netherlands had regularly and continuously oil leakage on gearboxes. The common sealing system using was lip seal.

At the end of 2002, IS Vof the Dutch distributor, propose a DOUBLE-RUNNER Bearing Isolator, on a “**equipment manufacturer**” parallel shaft gearbox.

The cover was machined to Bore Ø 160 mm, and the B.I was Press-Fit installed.

With NO OIL LEAKAGE in result, the customer starts to fit other different gearboxes.

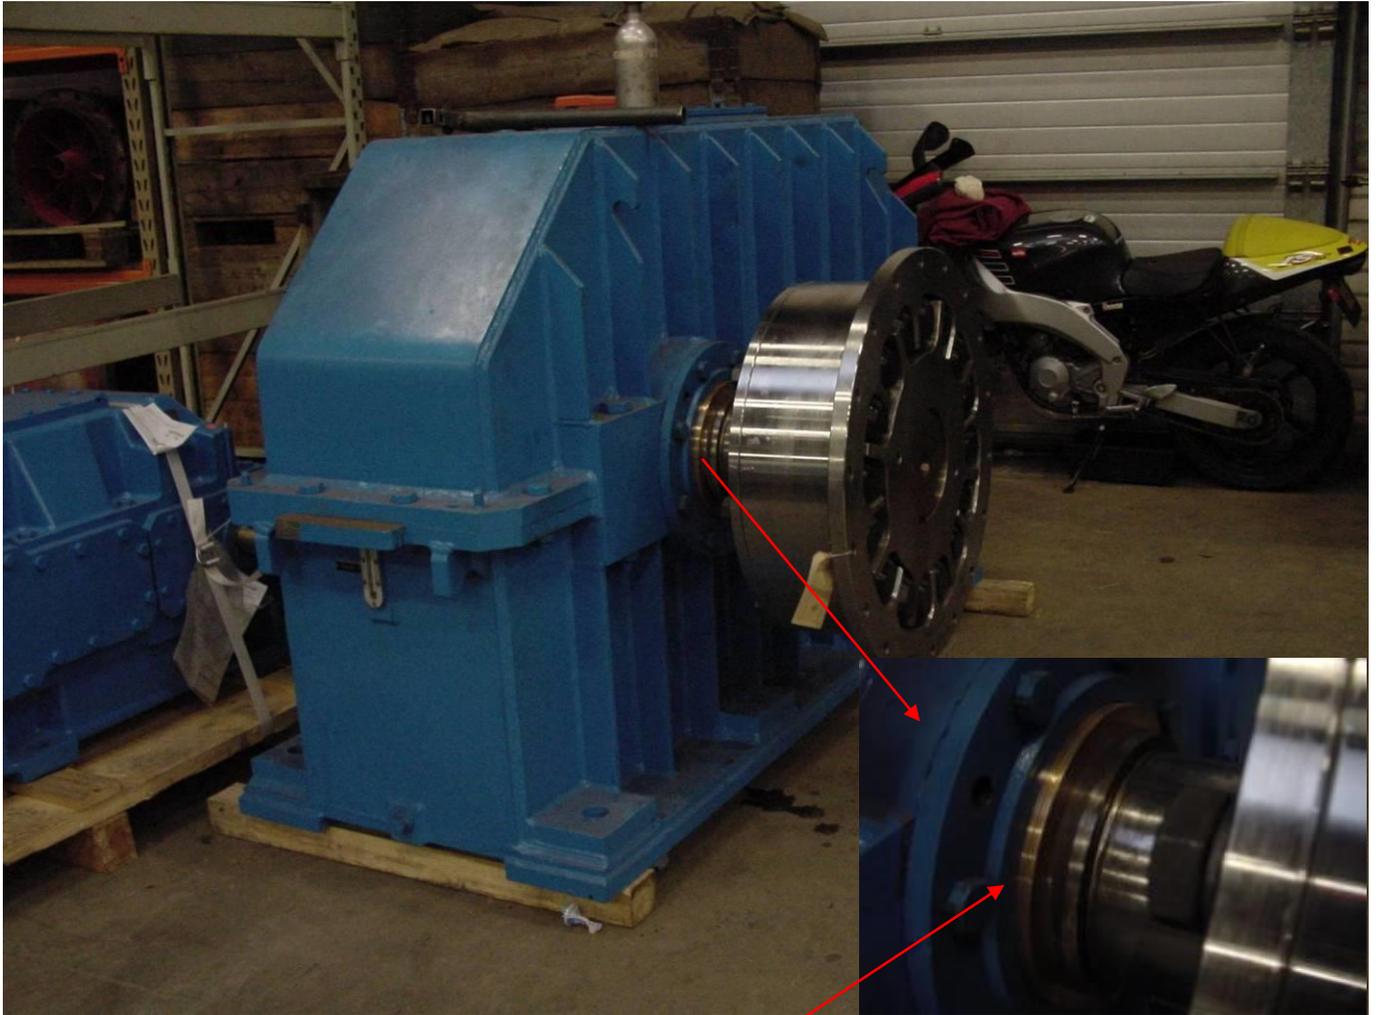
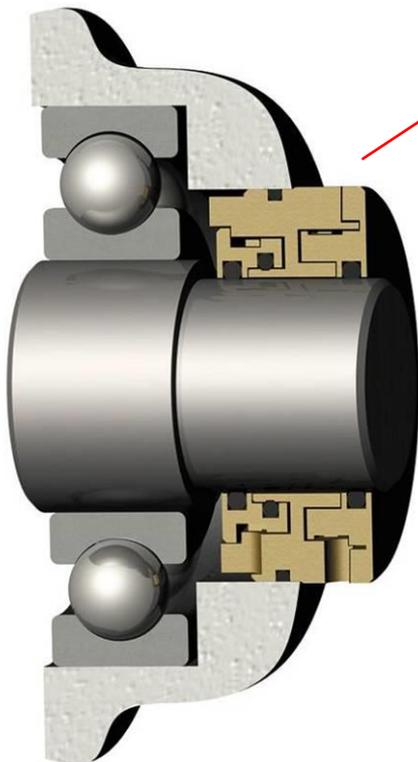
DOUBLE RUNNER

Shaft size : Ø 120 mm

Inpro B.I : B.I Type VBXX – DOUBLE - RUNNER.
